This sheet outlines the best practices for correcting the most common non-conformances identified in NYS Clean Heat Site Assessment Reports for ASHP Installations, and how to avoid these non-conformances in future reports. If you have any questions regarding best practices for contestation, please email <u>NYSCleanHeat@icf.com</u> for more information.

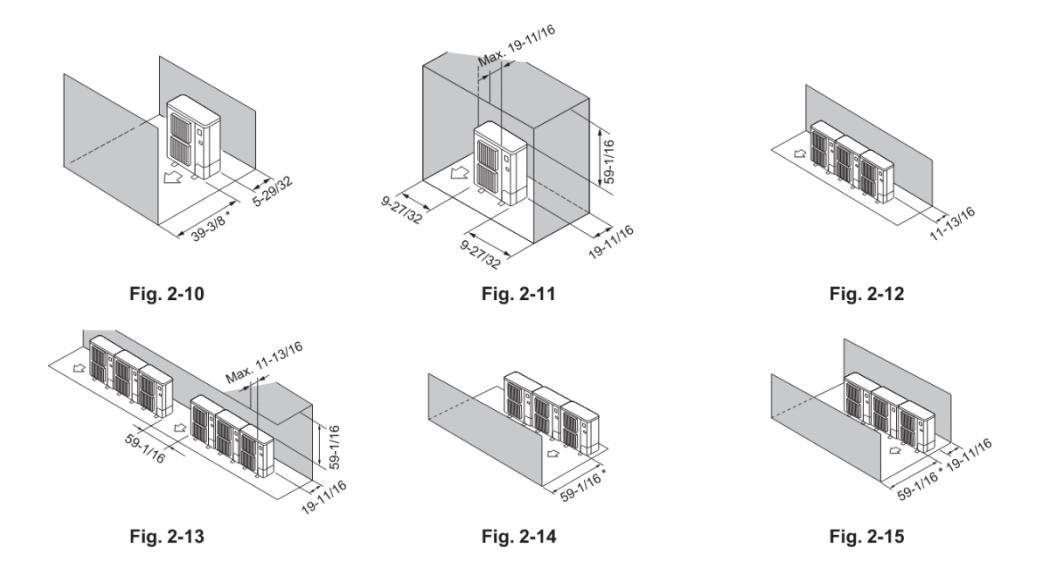
- Ensure that, in order to meet the clearances flagged in the report, you are not compromising clearance on another side of the system
- Ensure outdoor unit clearances meet the recommended distances outlined in the manufacturer's installation manual which correspond to the most similar installation configuration to conditions on site.
  - Clearance requirements may vary depending on how many sides of the unit are obstructed and whether multiple outdoor units are installed in an array

• Consider mounting on a free-standing mount if a wall-mount does not allow manufacturer's recommended clearance to be met
