Why Air Source Heat Pump Field Assessments Matter

NYS Clean Heat
Supported

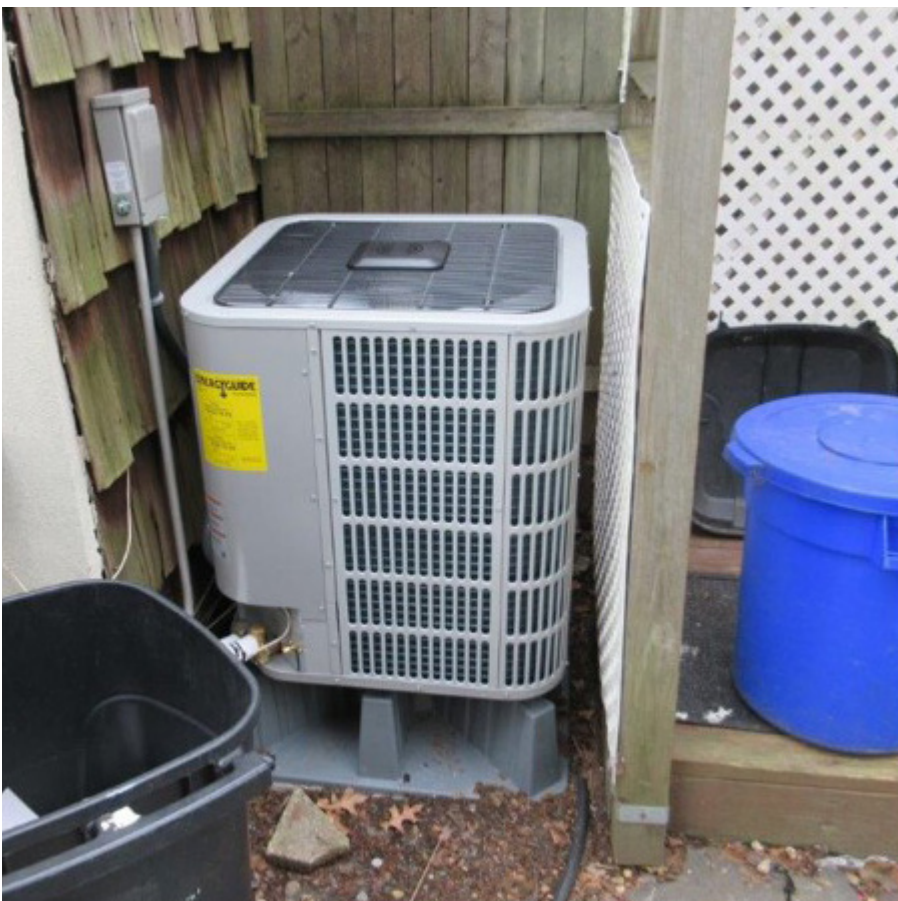
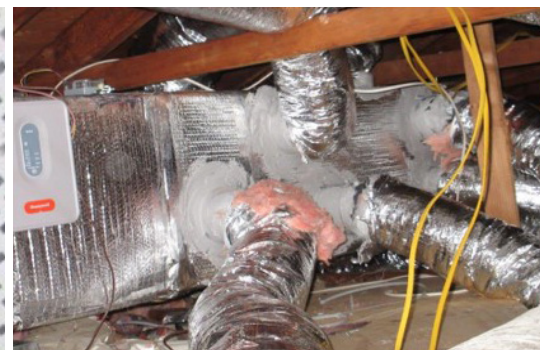
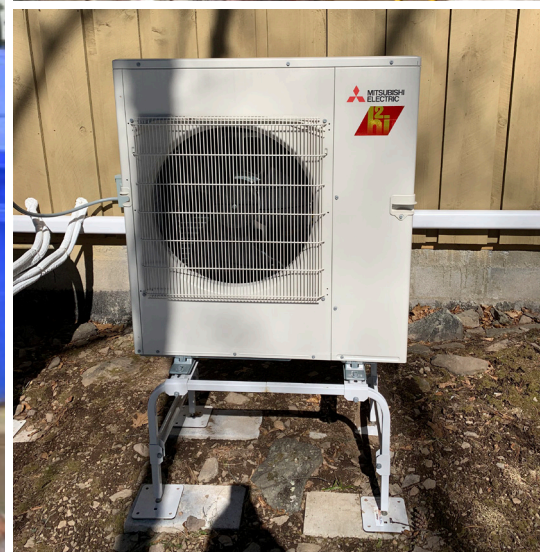
Table 1. ASHP Checklist Summary and Table 2 Reference Guide
